PERATION

GREENHOUSE

SCIENTIFIC DIRECTOR'S REPORT

ANNEX 3.2 U. S. NAVY STRUCTURES

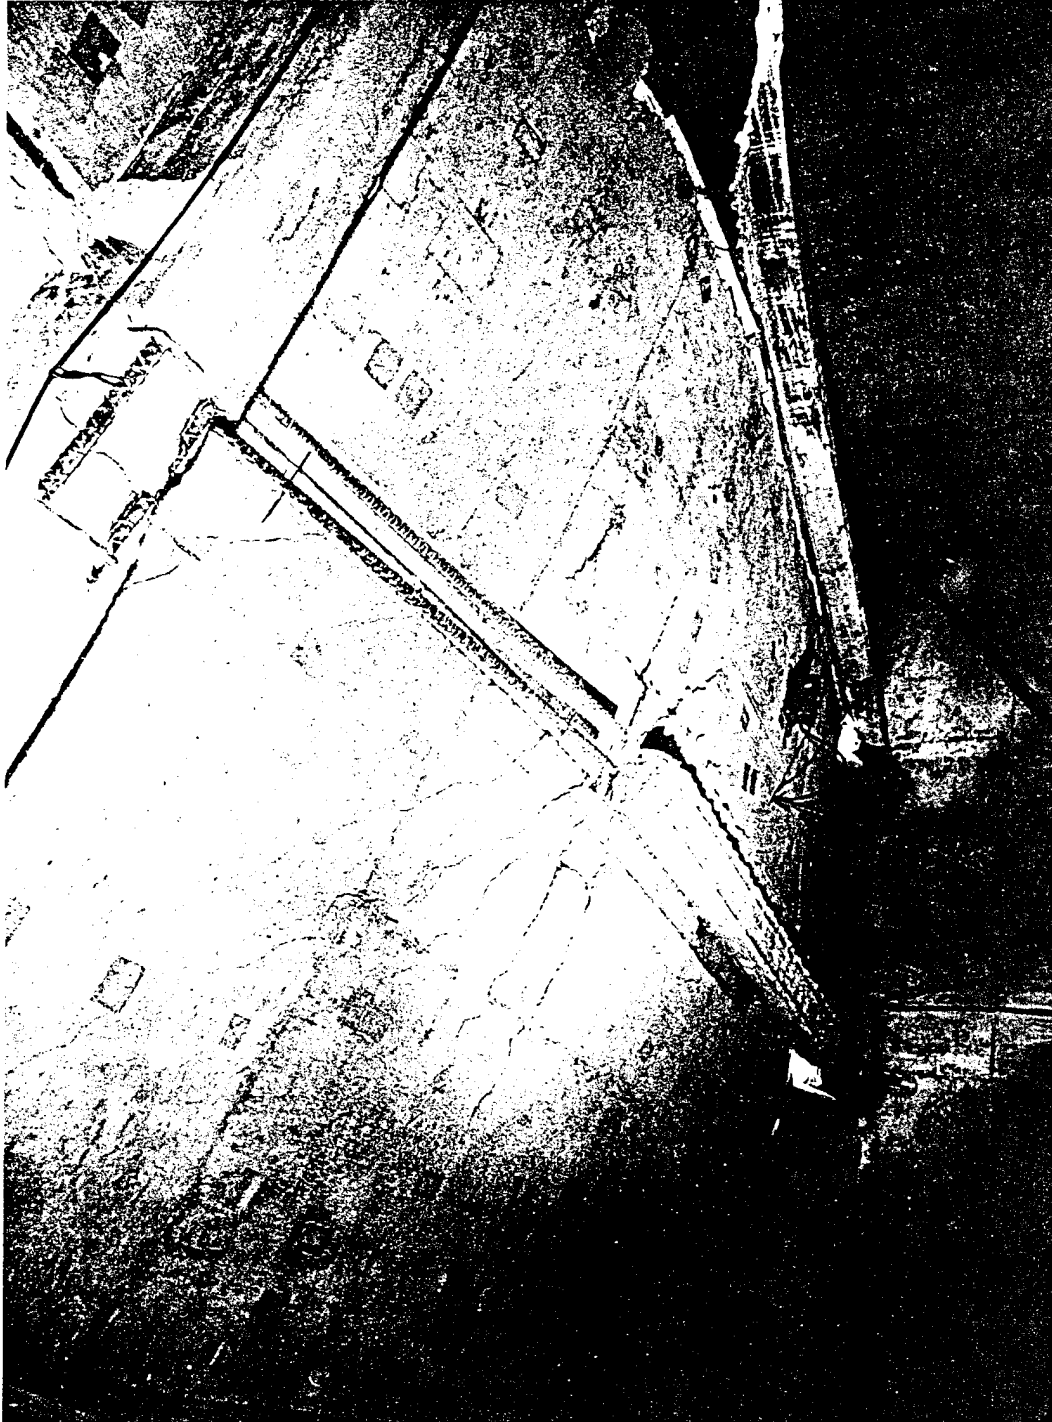
Fig. L. 524 Detail View of Stringer Beams under Right Half of Roof, Structure 3.2. 7b

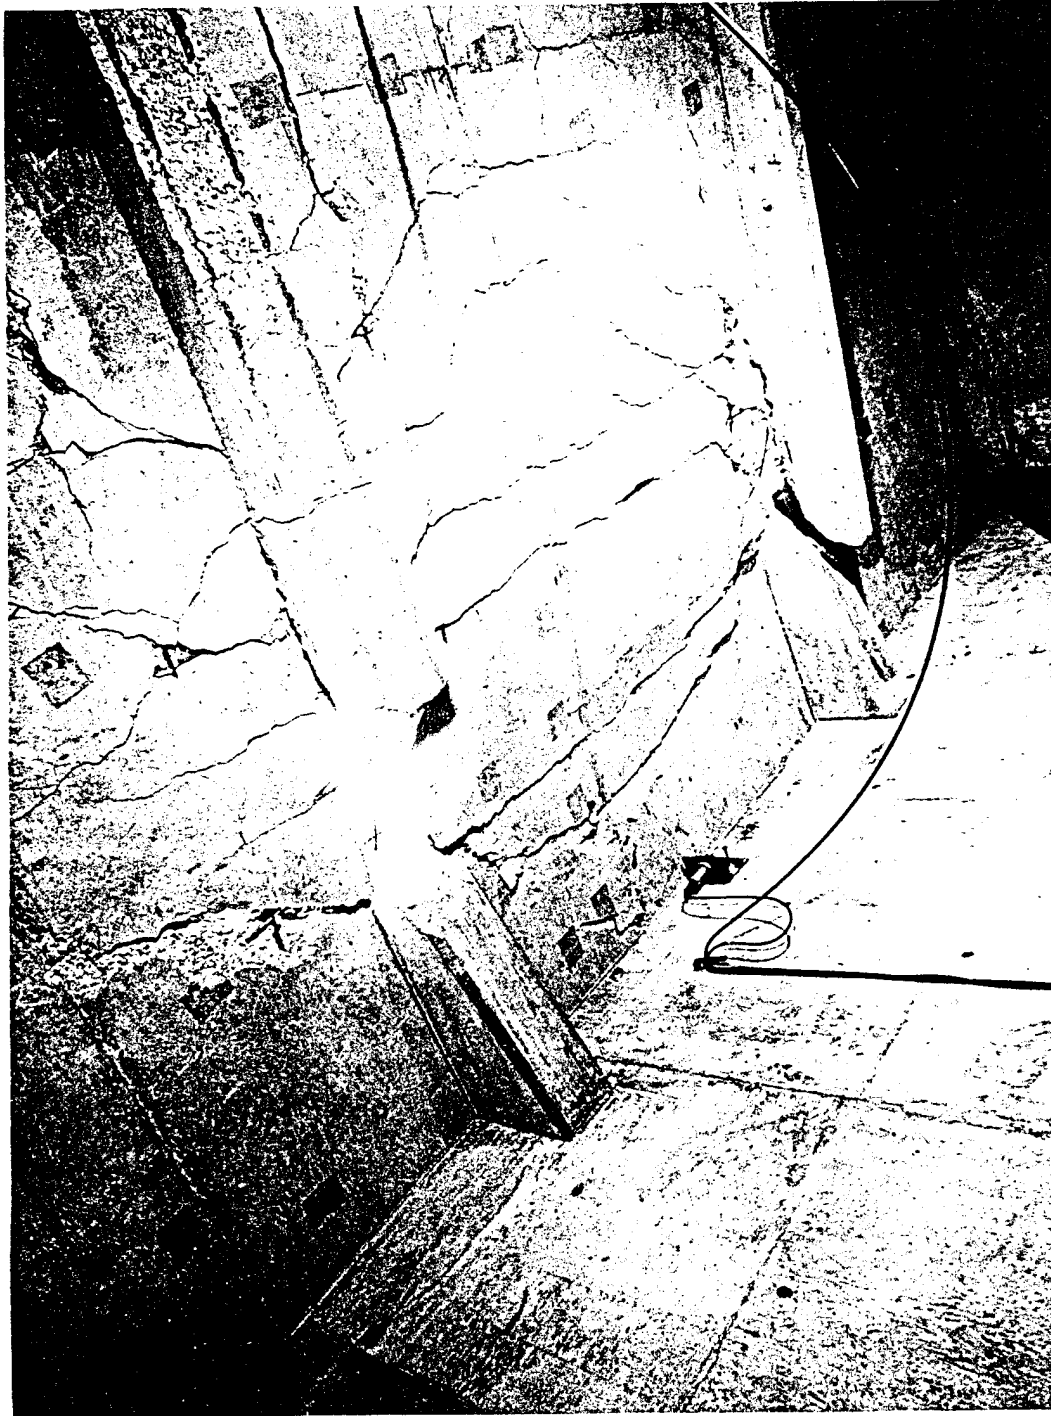
Fig. L. 525 Detail View of Method of Failure of Stringer Beams under Right Half of Roof, Structure 3. 2. 7b.

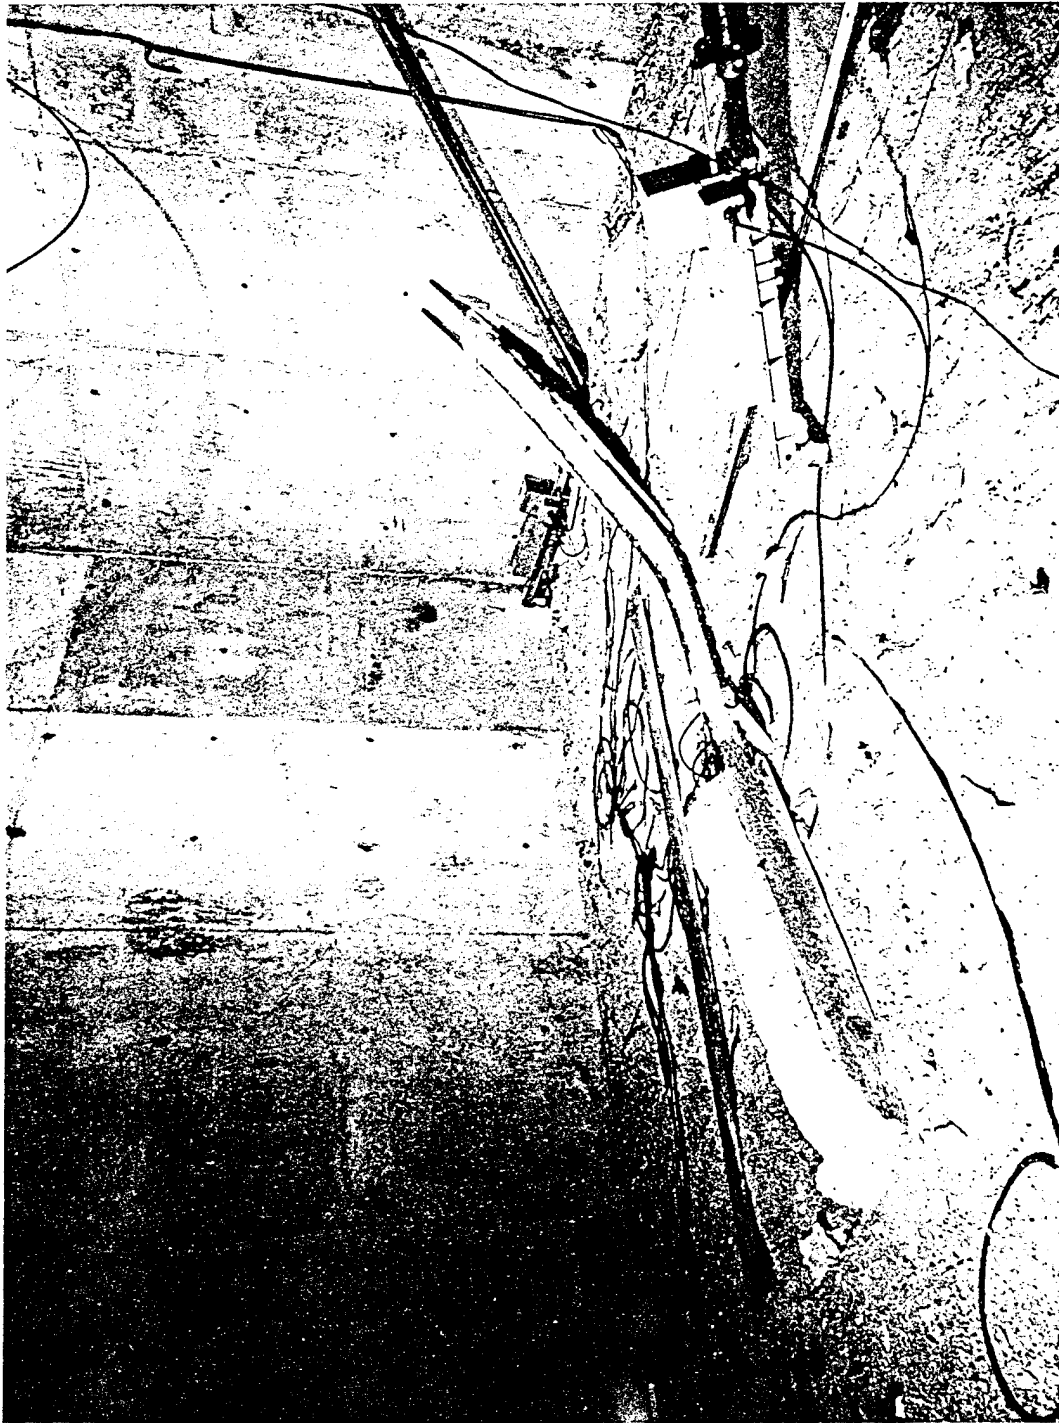
Fig. L. 526 Detail View of Bottom Half of Right Rear Stringer Beam, Structure 3.2. 7b

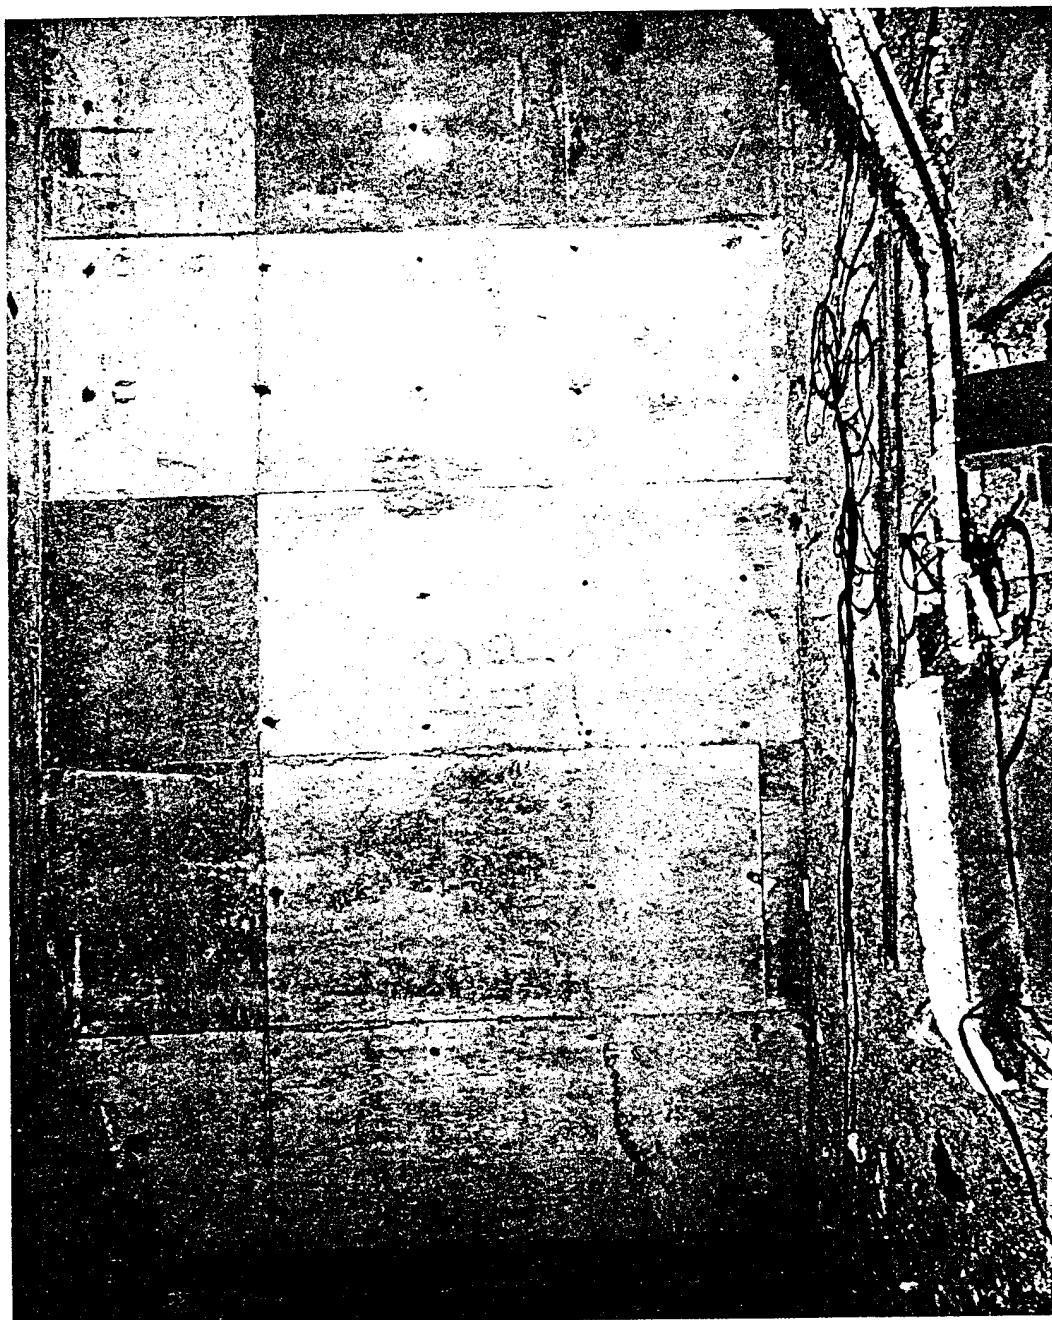
Fig. L. 527 Interior View of Right Half of Rear Wall, Structure 3.2. 7b

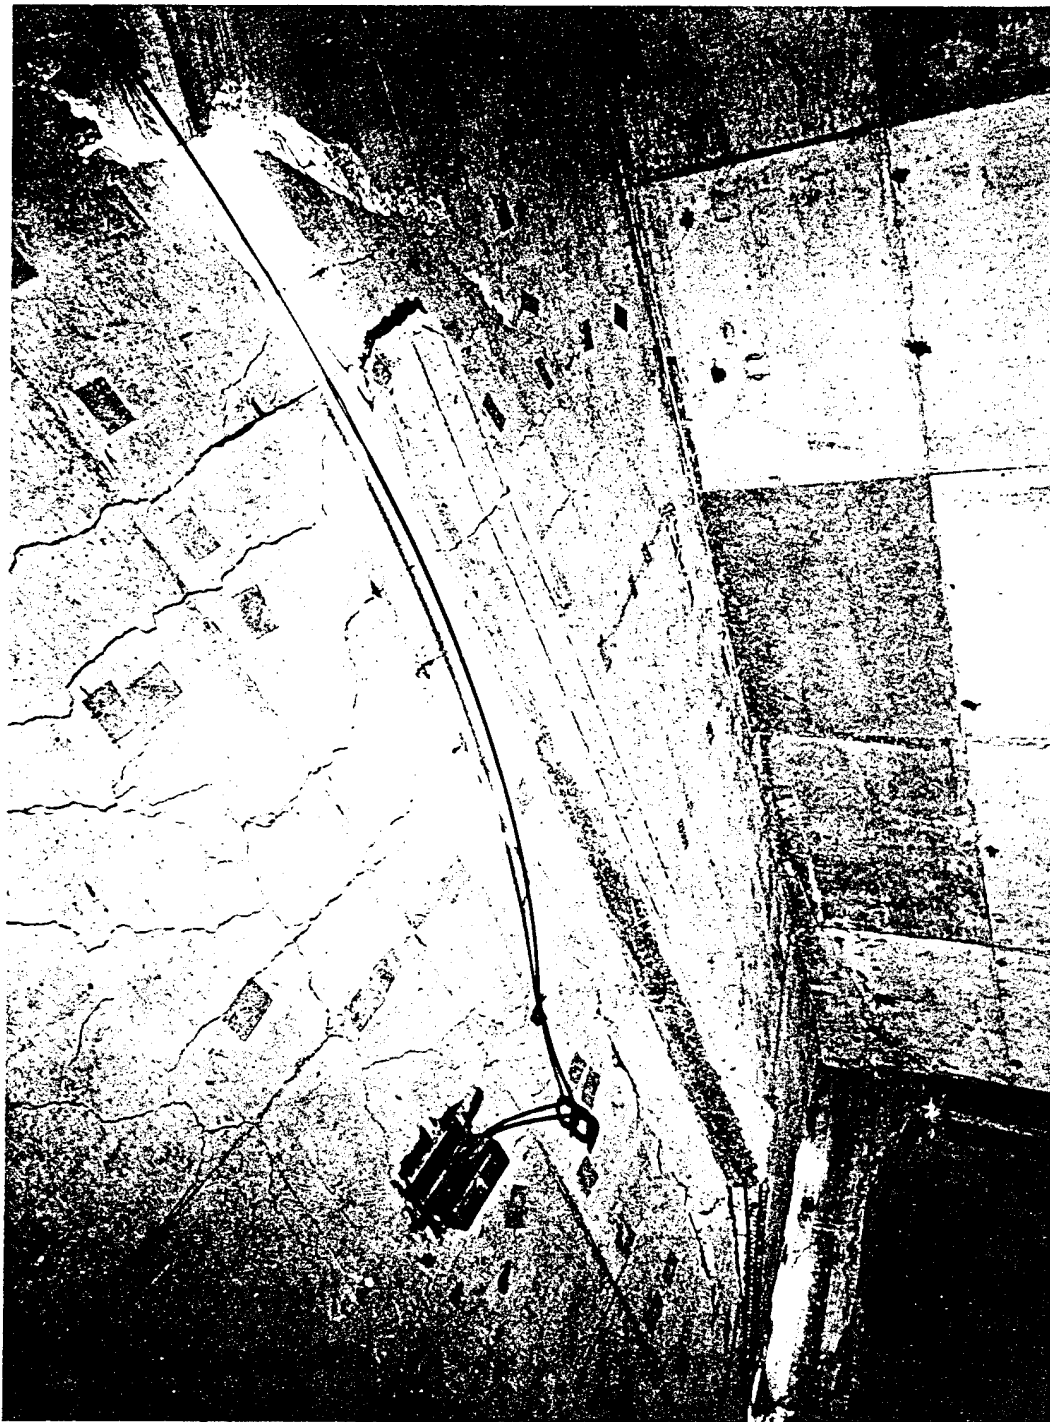
Fig. L. 528 Interior View of Main Girder Haunch at Rear Wall, Structure 3. 2. 7b

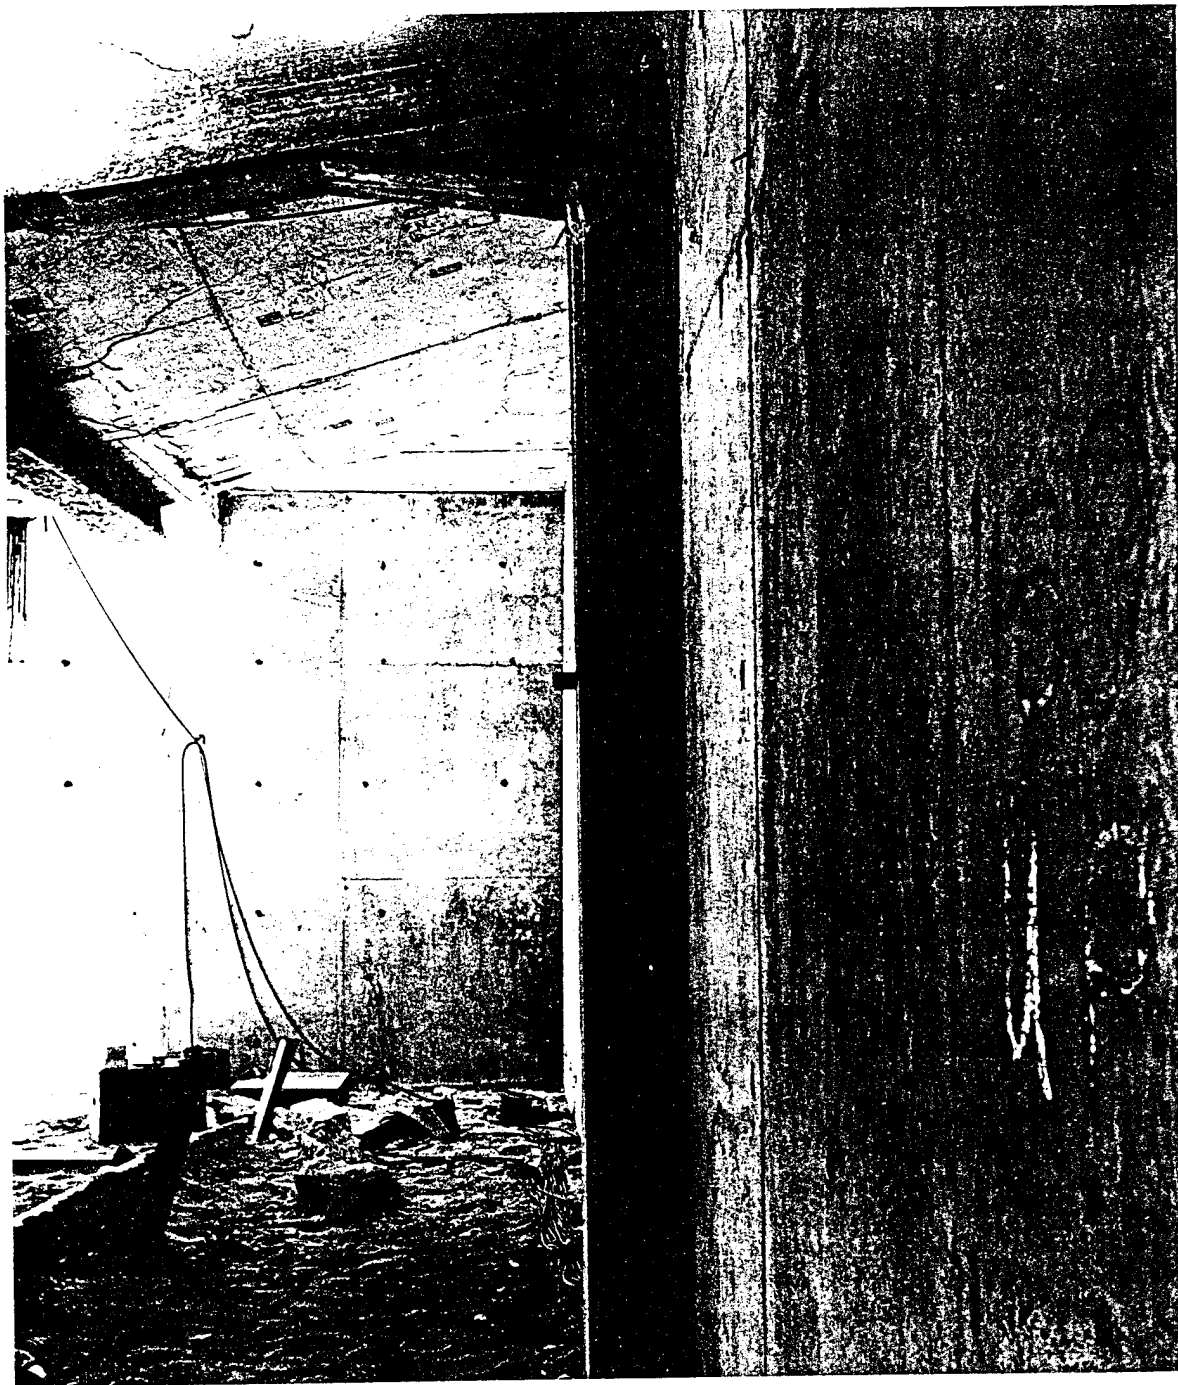
Fig. L. 529 Side View of Rear Pilaster and Failure of Main Girder Haunch at Rear Wall, Structure 3.2.7b

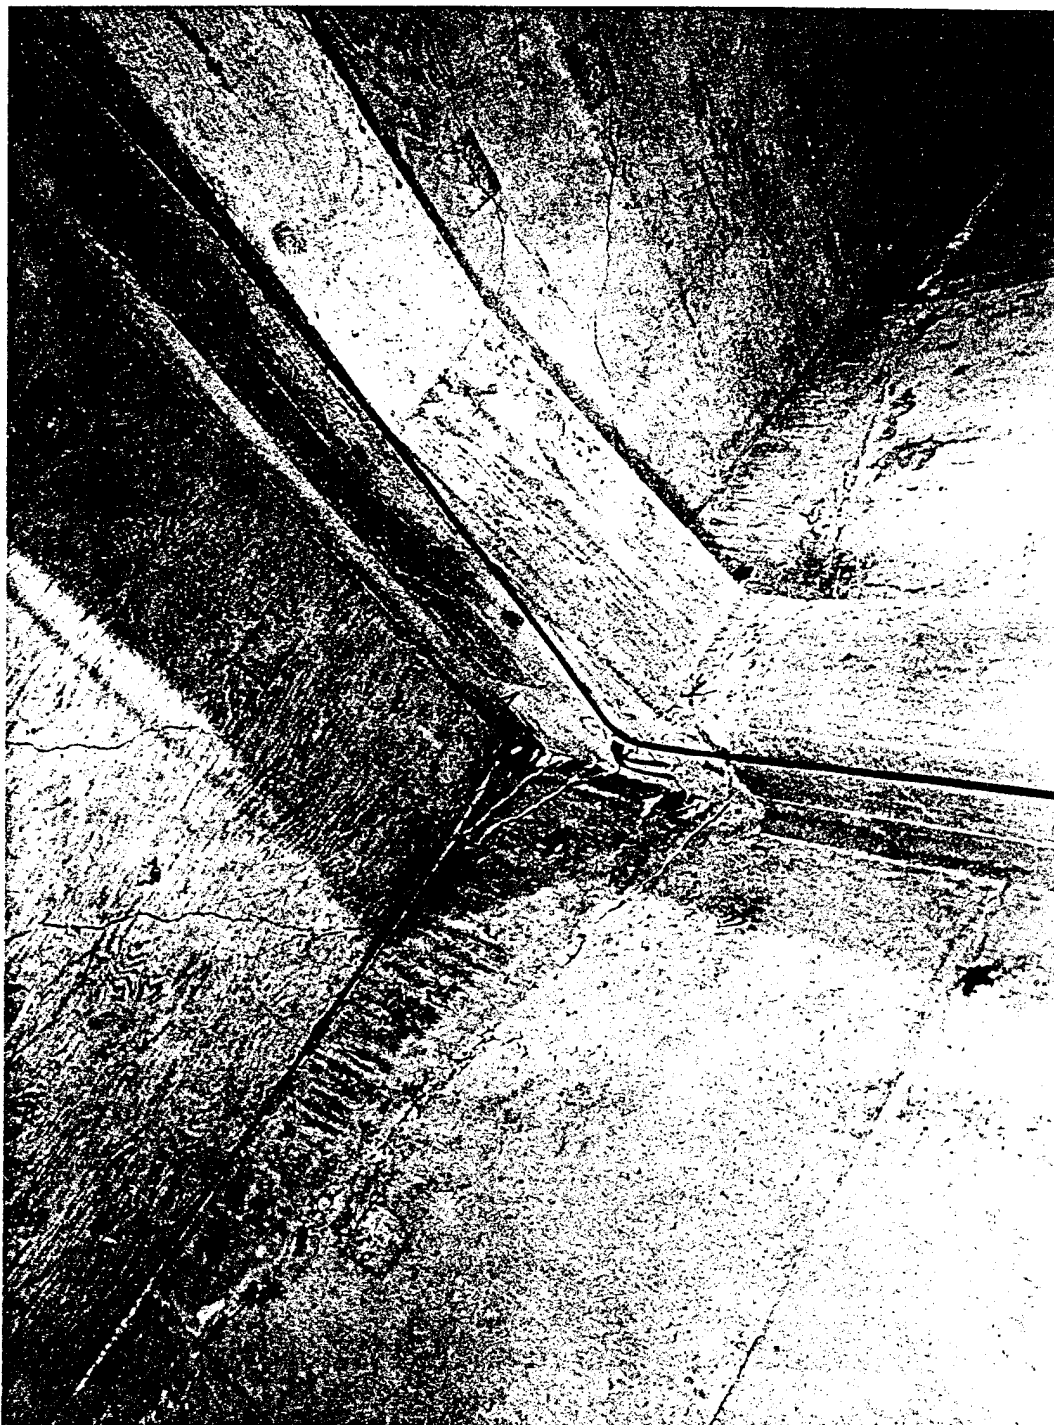
Fig. L. 530 Detail View of Main Girder Haunch at Rear Wall, Structure 3.2. 7b. Part of wall bent in with the haunch as it rotated inward. Note the crushing of the concrete at the underside of the haunch.

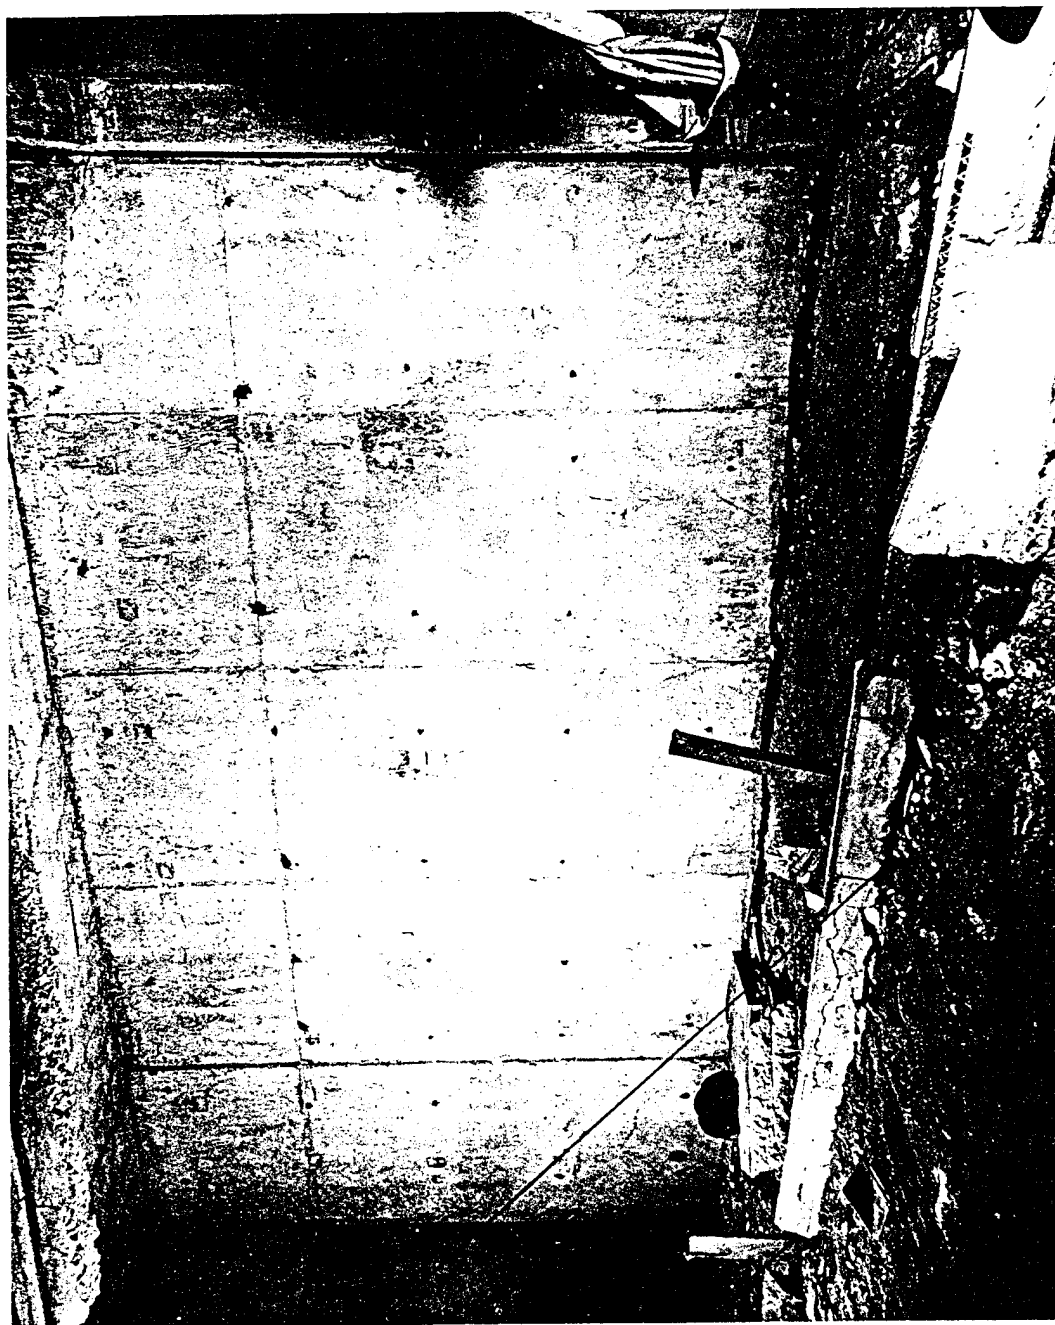
Fig. L. 531 Interior View of Left Half of Rear Wall, Structure 3.2. 7b. Lower half of left rear stringer beam can be seen on ground.

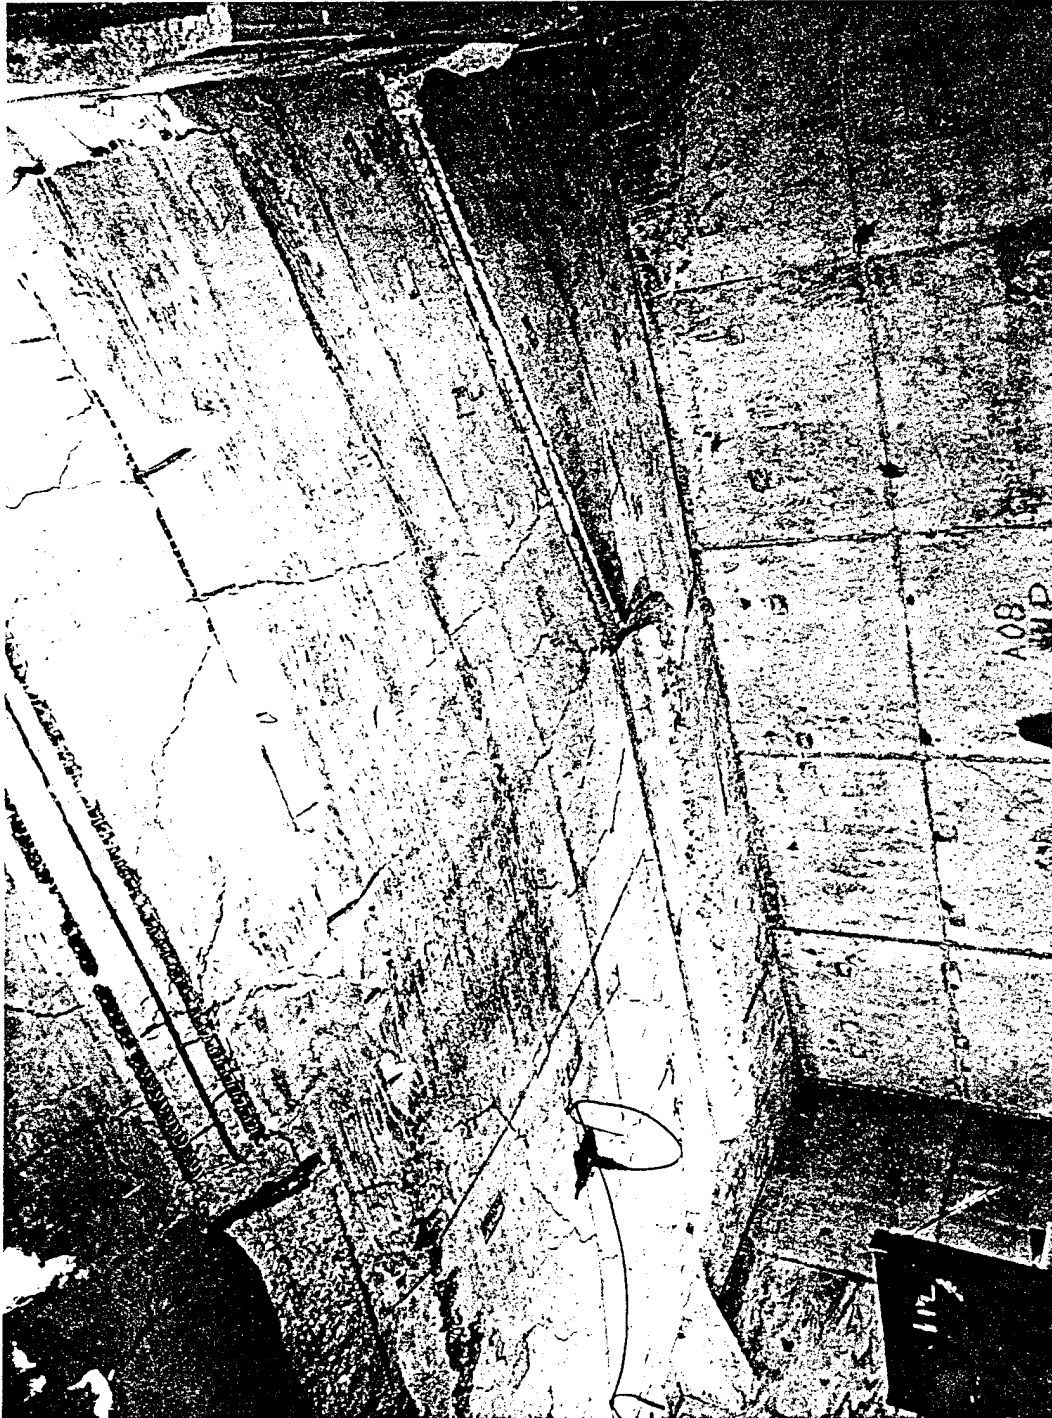
Fig. L. 532 Interior View of Rear Left Corner, Showing General Distling of the Roof Slab, Structure 3. 2. 7b

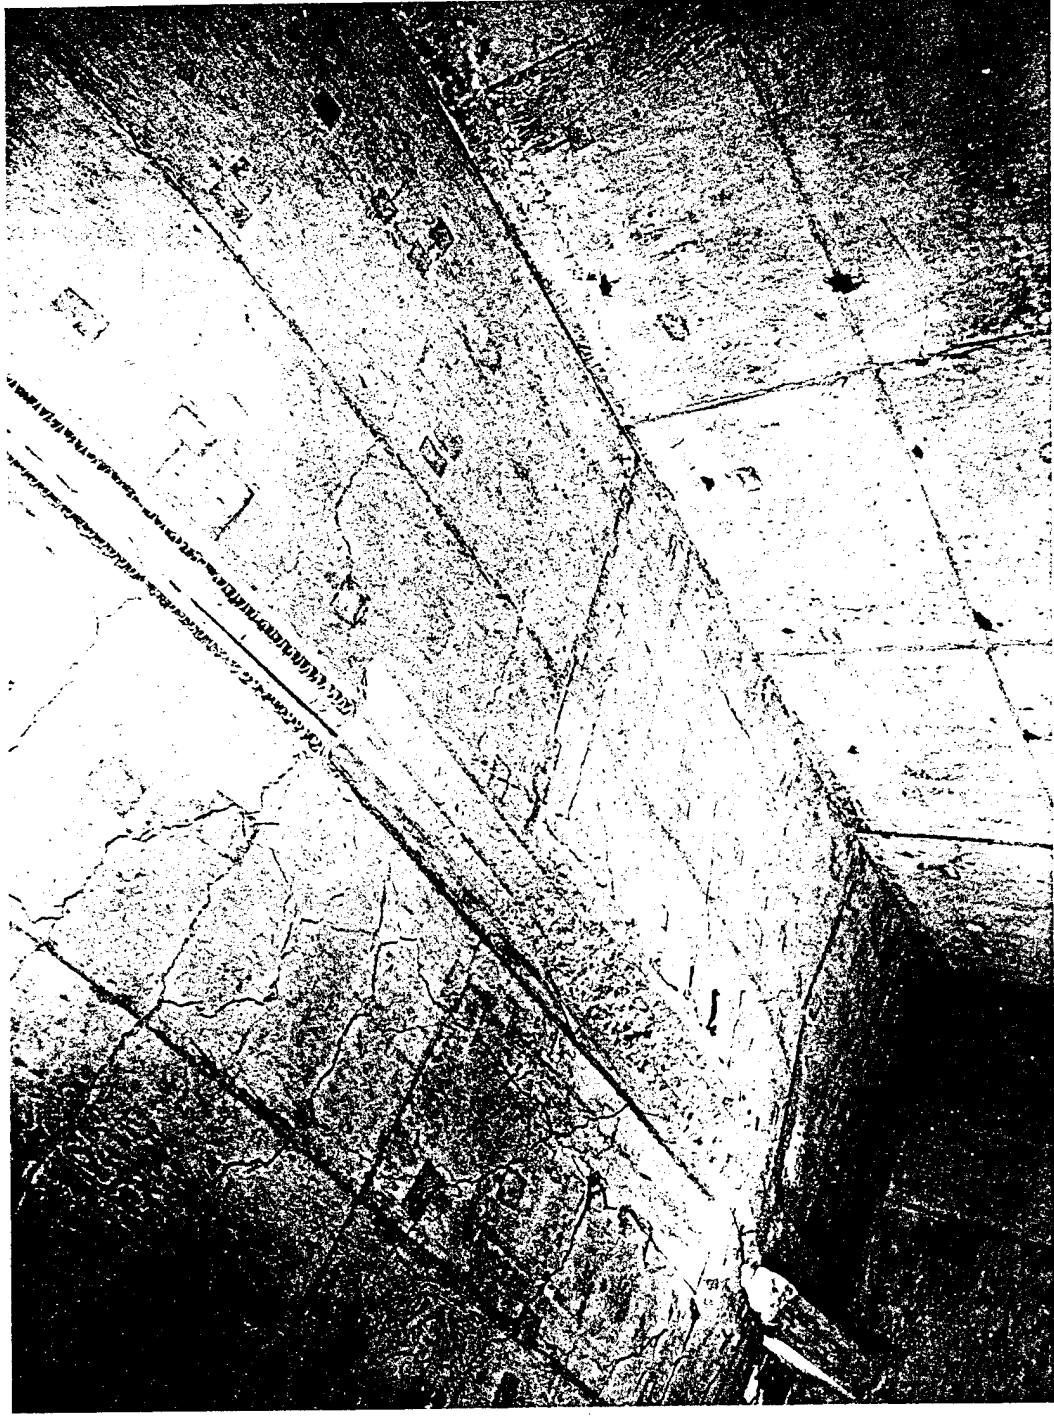
Fig. L. 533 Detail View of Crack Patterns in Underside of Roof, Structure 3. 2. 7b

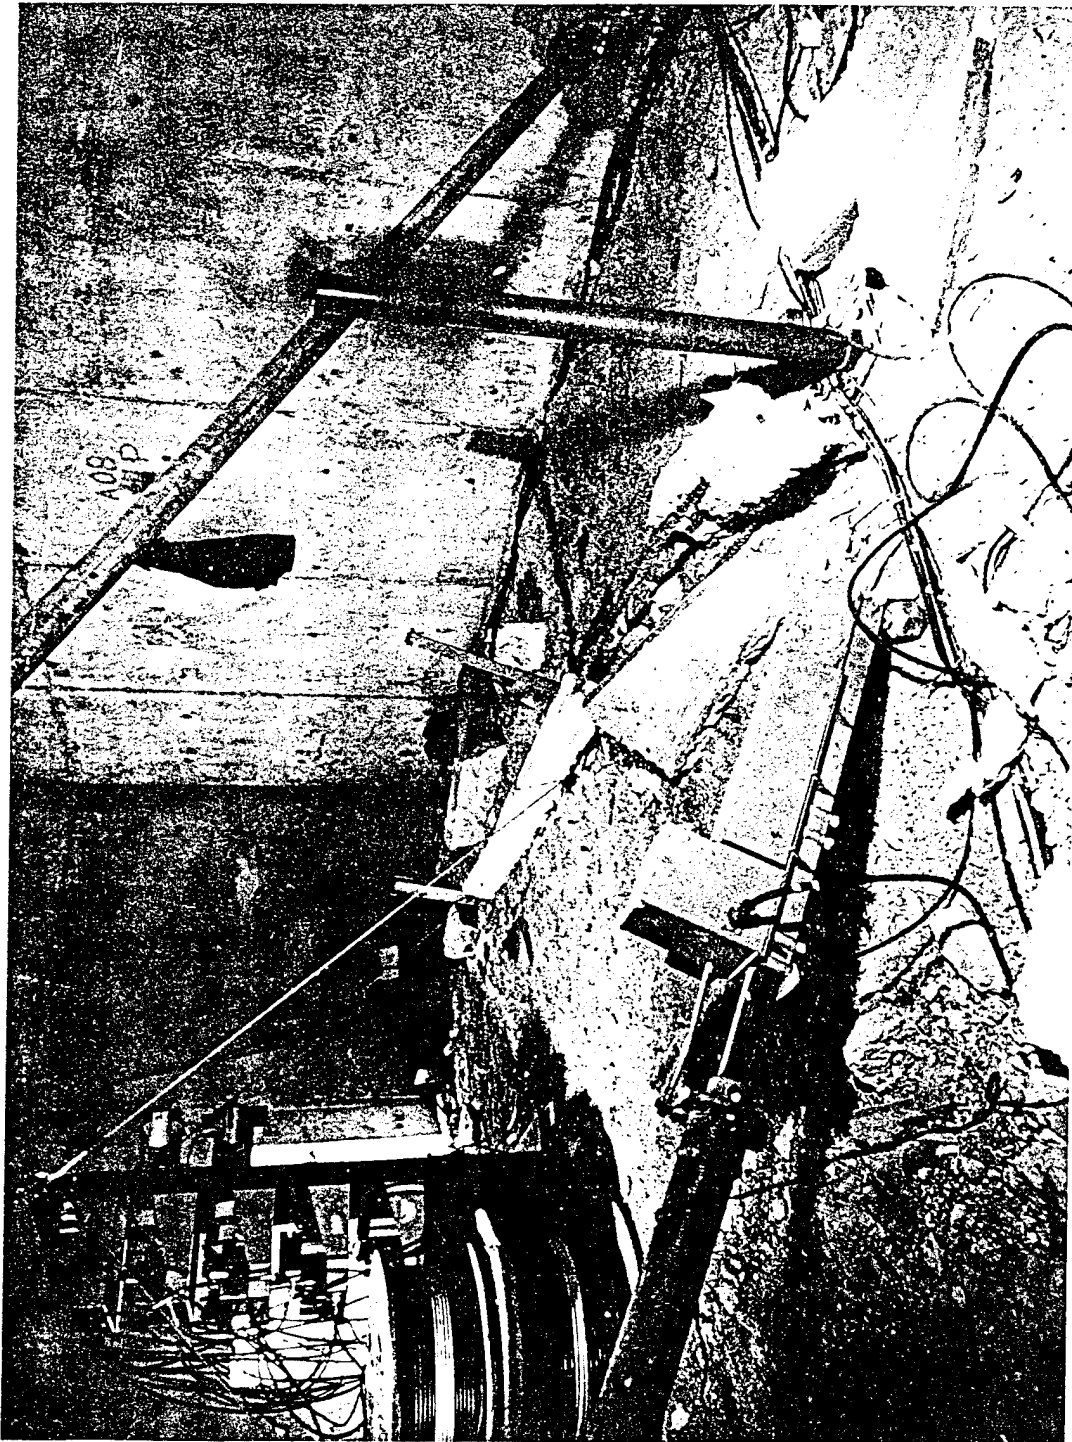
Fig. L. 534 Interior View at Ground Level of Left Rear Portion of Structure, 3.2. 7b
